TECHNICAL REPORT ARCCB-TR-99019

**FATIGUE LIFE ASSESSMENT OF  
155-MM M776 CANNON TUBES**

**US ARMY ARMAMENT RESEARCH,  
DEVELOPMENT AND ENGINEERING CENTER  
CLOSE COMBAT ARMAMENTS CENTER  
BENÉT LABORATORIES  
WATERVLIET, N.Y. 12189-4050**

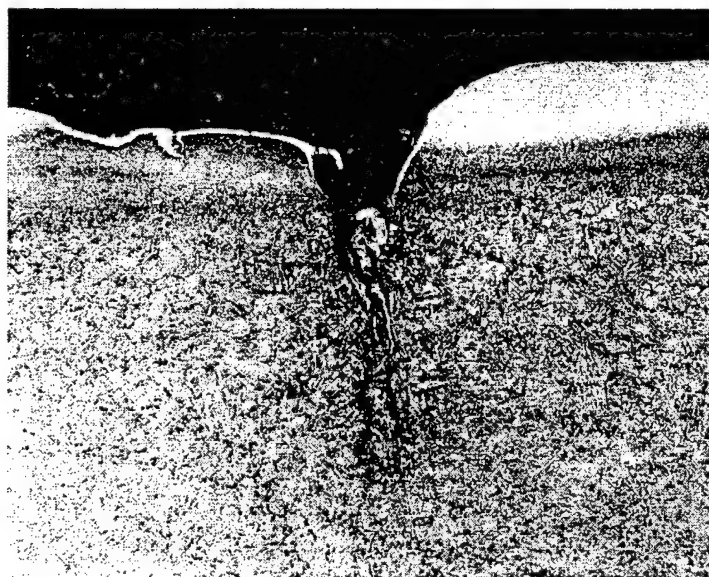
Figure 4. Continued fatigue crack growth plus substrate melting and chromium loss.

Figure 1 illustrates a macroscopic view of a typical bore surface after sufficient live fire rounds have been applied for the commencement of laboratory cycling. The heat-checking, or "dry lake bed" appearance, is apparent. Figure 2 is a transverse section of Figure 1 showing the uniform array of heat checks and the fatigue cracks that grow from heat checks. The heat checking in this photograph ranges from 0.010-inch to 0.020-inch. Figure 3 is a high magnification micrograph of Figure 2. Once again, a fatigue crack emanating from a heat-check location is apparent. Finally, Figure 4 shows how a heat-check crack has initiated a fatigue crack that has penetrated through the chromium plate and into the base metal causing chromium loss

and substrate melting. With acceptable bore damage developed during prelaboratory live firing, laboratory fatigue testing has proven to be equivalent to test firing in propagating this initial damage to failure.

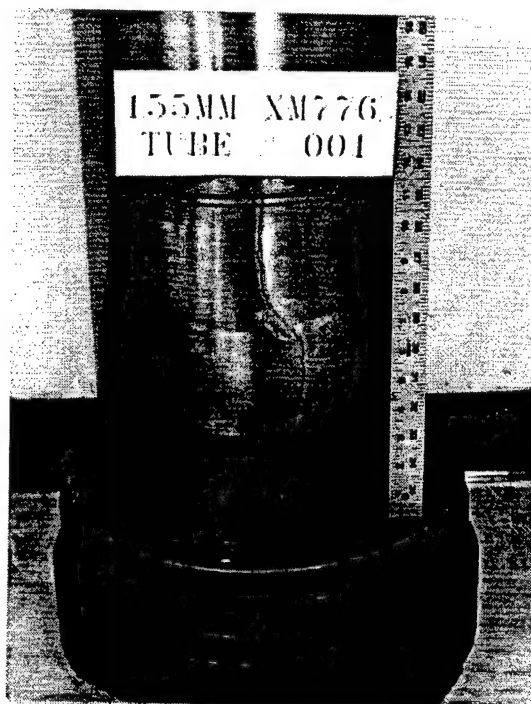
Figure 11. XM776 S/N 001 breech end failure site (enlarged view).

Figures 9 and 10 show failure locations of the two breech end test sections. Figures 11 and 12 show an enlarged view of the breech end test sections and the failure location. The fracture surface for each breech end test section is shown in Figures 13 and 14. Figures 15 and 16 illustrate the two keyway test sections with the failure location noted. Figures 17 and 18

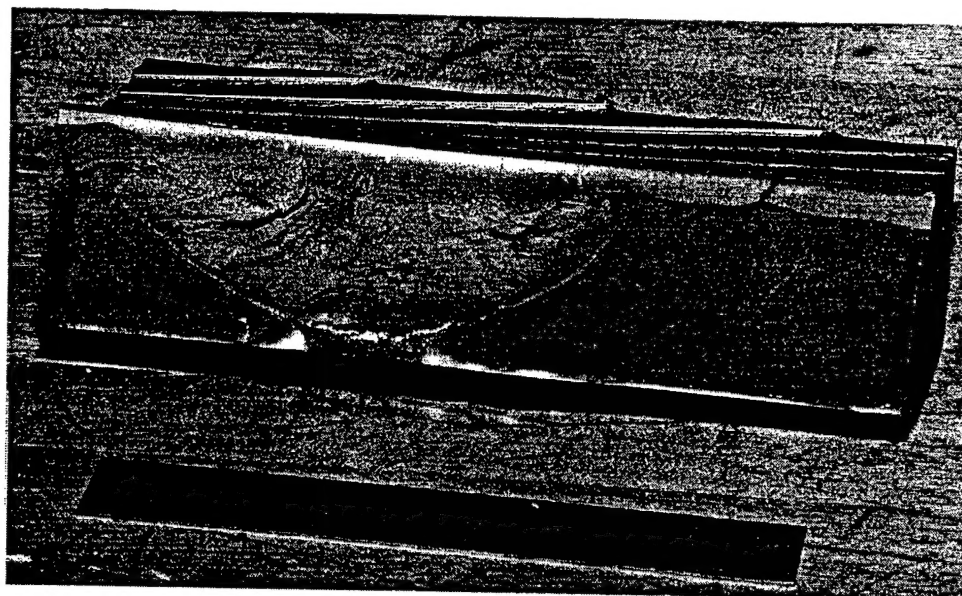
Figure 19. XM776 S/N 001 keyway fracture surface.

illustrate an enlarged view of the keyway test sections with the failure location noted. The fracture surface for each keyway test section is shown in Figures 19 and 20.

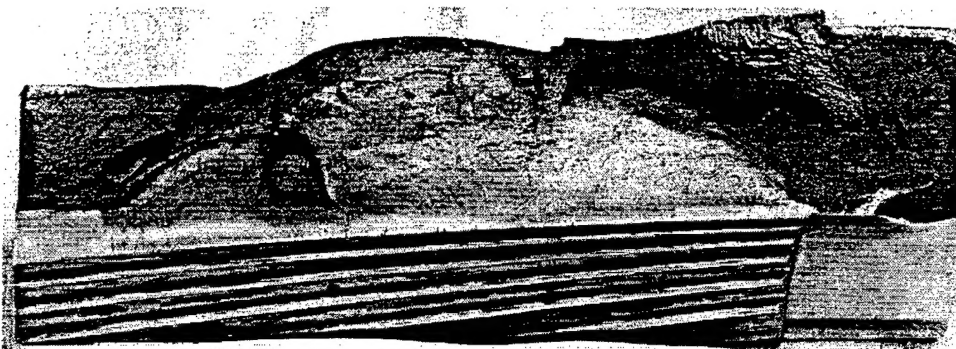
**155mm XM776 Lightweight  
Tube #003  
17,457 Lab Cycles**

Figure 20. XM776 S/N 003 keyway fracture surface.
